**CEESEN-BENDER**

**Building intErventions in vulNerable Districts against  
Energy poveRty**

**Deliverable 2.4**

**Synthesis report on demonstration buildings**

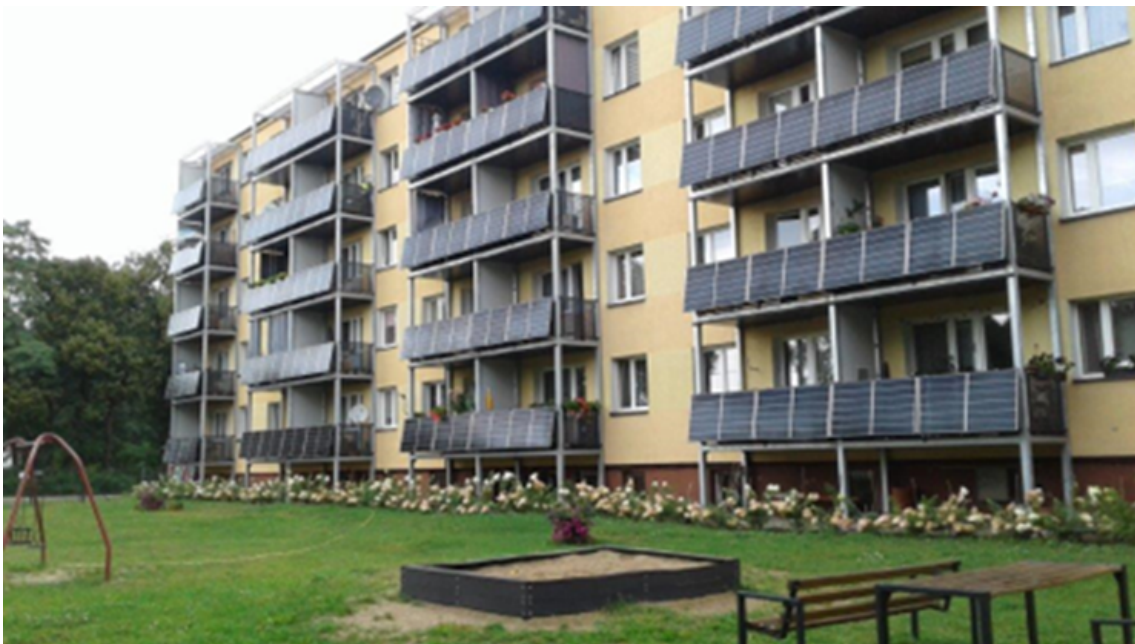
Figure 1. Demonstration building in Poland.

The building is located at Śląska 12, in Szczytno Town. Constructed in 1974, the building exhibits a gross floor area of 1 907,52 m<sup>2</sup> distributed across four above-ground floors plus a basement, accommodating 40 apartments with an average area of 46,66 m<sup>2</sup>. The heating system relies on a partially modernized radiator network powered by two NIBE F1345-60 ground-source heat pumps arranged in a cascade configuration with a total capacity of 120 kW. This system is supplemented by a 40 kW photovoltaic (PV) installation. Additionally, the building incorporates multiple energy generation systems: a 40 kW rooftop PV array, vacuum solar panels for domestic hot water (DHW) production, and a further 32 kW PV system mounted on the balcony structures. Annual electricity consumption for DHW is approximately 35 000 kWh, with an average quarterly consumption of around 300 m<sup>3</sup> - equating to roughly 3,75 m<sup>3</sup> per resident

Over the years, the building has undergone a series of renovations that have significantly improved its energy efficiency, thermal insulation, and overall safety. In 2005, a complete renovation of the stairwells, including the replacement of entrance doors and windows, was undertaken. This was followed in 2006 by a roof renovation that incorporated insulation for the roof-ceiling assembly, financed by a 60 000 PLN (13 954 EUR) loan. A major thermal modernization project was carried out between 2008 and 2009, during which vestibules were constructed 80% of the windows and balcony doors were replaced, and balcony renovations were completed with financial support from a 100 000 PLN (23 256 EUR). In 2010, the electrical installations in the basement and common areas were upgraded to a 24V system, and the horizontal water supply network was replaced, including the installation of a limescale removal device that not only improved drinking water quality but also extended the lifespan of heating elements by approximately 80%. Further external improvements were made in 2011 with the construction of sidewalks and a parking lot featuring a stormwater drainage system, an initiative that was self-financed at a cost of 70 000 PLN (16 279 EUR).

The integration of renewable energy sources was significantly advanced in 2014 with the installation of a 40 kW PV system on the building's roof and the deployment of the ground-source heat pumps. In 2016, the building's cold water supply risers were replaced, and a radio water meter reading system was installed, a project self-financed with 25 000 PLN (5 814 EUR). The DHW system was further enhanced in 2017 by incorporating renewable energy sources through air-water heat pumps and

additional solar installations. In 2022, attached balconies were constructed and an extra 32 kW PV system was installed on the balcony structures to support DHW heating. Most recently, in 2024 a rainwater drainage system was constructed to channel roof runoff into a retention tank for irrigating the green areas in front of the community building, with part of this project financed through a 10% loan forgiveness mechanism from earlier funding.

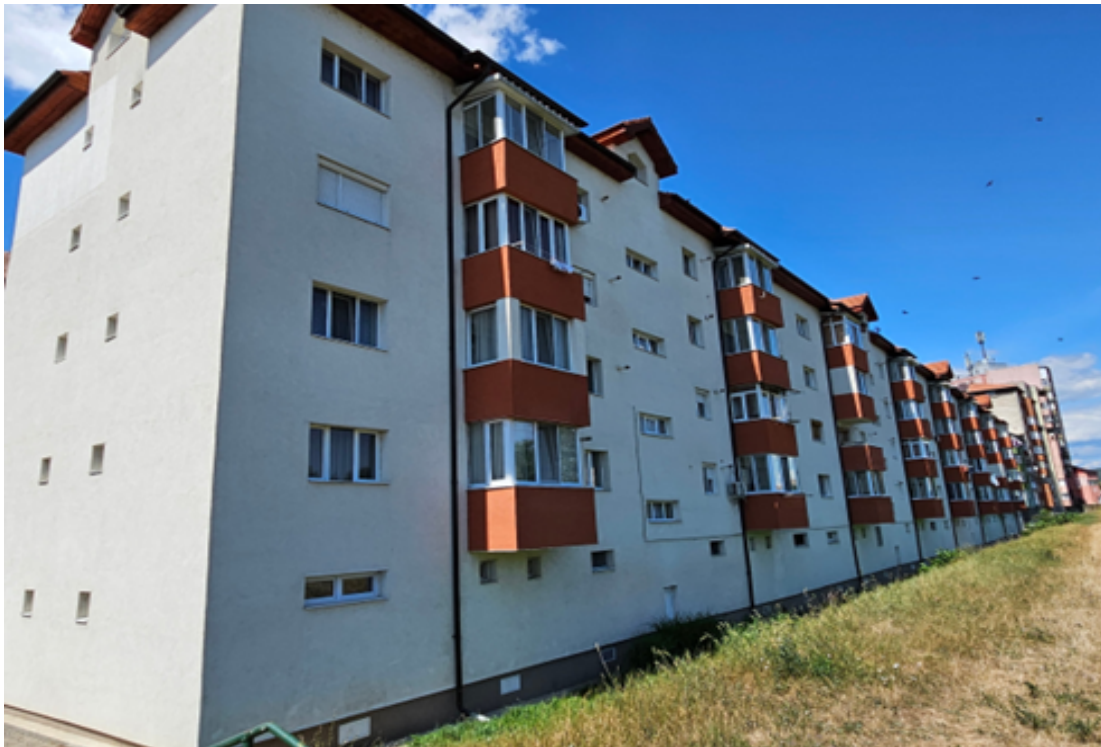
*Figure 2. Demonstration building in Romania.*

Constructed in 1978, the residential building located at Livezii 49, Alba Iulia Municipality, Romania, has a gross building area of 5 215 m<sup>2</sup> and a conditioned floor area of 4 518 m<sup>2</sup>. It consists of four above-ground floors and accommodates 64 apartments, each with an average heated area of 70,59 m<sup>2</sup>. The conditioned volume of the building is 11 749 m<sup>3</sup>.

The renovation primarily focused on thermal insulation measures, including roof and attic insulation, external wall insulation, replacement of exterior windows, balcony

doors, and entrance doors with thermopane units, as well as waterproofing of the foundation and standard facade painting. These interventions significantly improved the building's energy performance, leading to enhanced thermal comfort, reduced heating costs, improved noise insulation, and lower indoor humidity levels, contributing to better air quality and a reduction in mold formation.

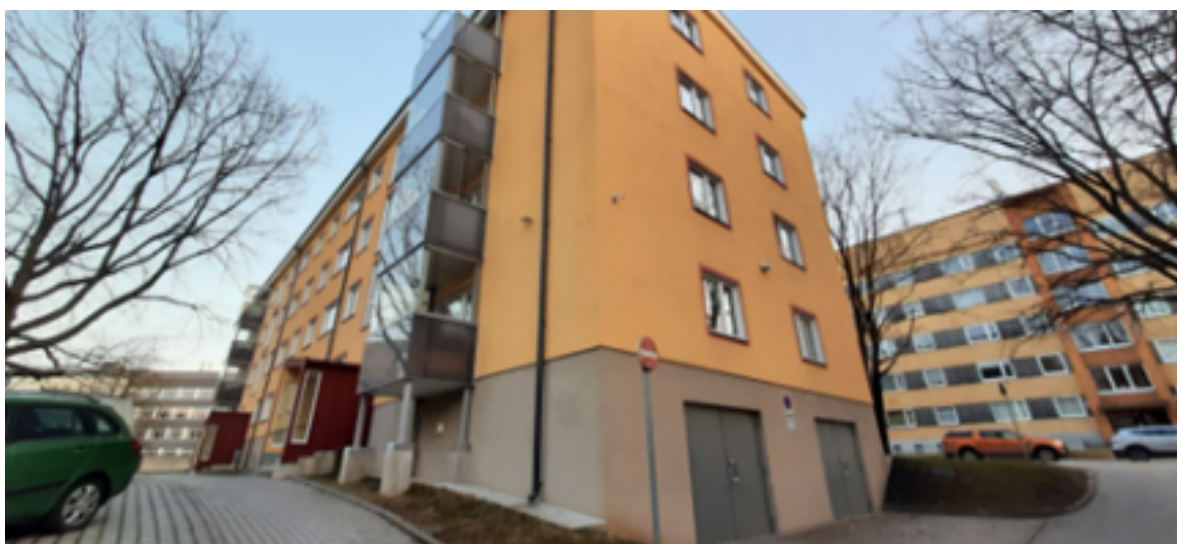
*Figure 4. Demonstration building in Estonia.*

The multi-apartment residential building located at Tähe 2 in Tartu City, Estonia, was originally constructed in 1964. It consists of 32 privately owned apartments, with a total gross building area of 1 776.4 m<sup>2</sup>, of which 1 440 m<sup>2</sup> constitutes heated space. The structure spans four floors and has an average apartment size of 42,3 m<sup>2</sup>.

The building is connected to a district heating network, which supplies both space heating and DHW. The energy carrier for heating is primarily biomass (over 90%), while natural gas is utilized for cooking. Electricity consumption is offset by an on-site PV system, which partially covers the building's energy demand and feeds excess electricity back into the grid. Prior to renovation, space heating relied entirely on district heating, consuming 289 MWh per year, while water heating and cooking were

supported by natural gas (32,6 MWh per year) and overall electricity consumption amounted to 38,7 MWh per year. Post-renovation, space heating consumption was reduced to 105 MWh per year, water heating to 35 MWh per year, and natural gas usage dropped significantly to 5,2 MWh per year. Electricity consumption remained relatively stable at 40,2 MWh per year, with PV generation contributing 27,5 MWh annually, of which 19,3 MWh was fed into the grid.

Energy efficiency improvements were substantial, elevating the building's classification from an F-class (pre-renovation energy efficiency index of 257 kWh/m<sup>2</sup> per year) to an A-class (post-renovation index of 74 kWh/m<sup>2</sup> per year). The primary renovation measures included a full building envelope upgrade, incorporating insulation of external walls, roof, and first-floor flooring, as well as the complete replacement of all doors and windows. These interventions resulted in an energy performance certificate (EPC) based energy consumption reduction of 68%, with a 36% decrease in district heating demand, a marginal 1% reduction in electricity usage, and an 84% drop in natural gas consumption.

Mechanical engineering enhancements included the transition of DHW heating from natural gas to district heating and the implementation of centralized heating controls. Each apartment is now equipped with a central control unit, allowing room-based temperature regulation through radiator thermostats and control and monitor ventilation system. Building was equipped with a demand-based (CO<sub>2</sub>) heat recovery ventilation system, which adjusts airflow of the main unit and also regulates the apartment's VAV (Variable Air Volume) dampers according to occupancy needs. Electrical system upgrades included the installation of a PV plant and comprehensive modernization of the building's electrical infrastructure.
